## Case Study: High-Rise Fire at Marina Sunset Hotel

Wayne Jones, Clyde & Co LLP  
Alfred Thornton, Clyde & Co LLP  
Michael Ducker, Clyde & Co LLP  
David Summers, Cunningham Lindsey;  
Daniel Jackson, Burgoyne; and  
Daniel Thorpe, MDD Forensic Accountants

22 March 2017

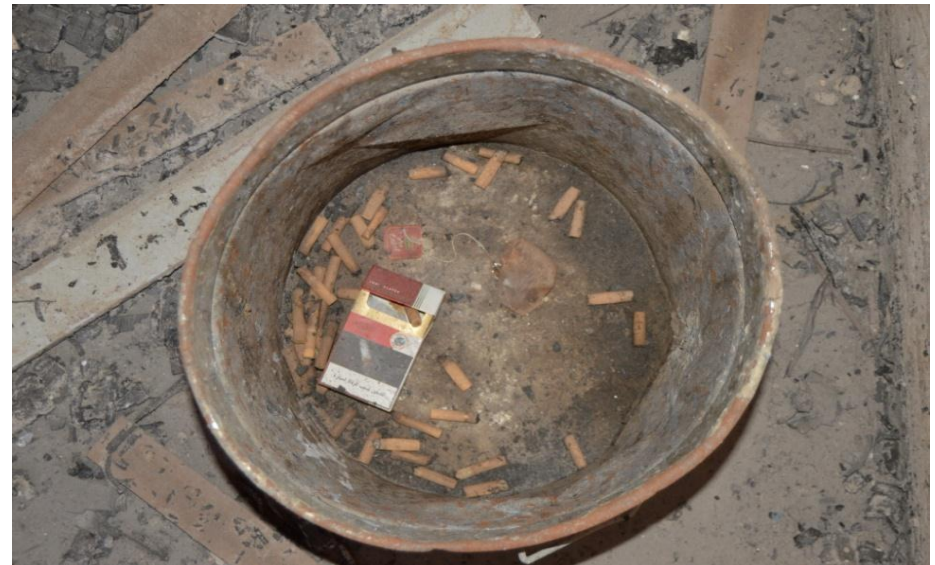
# Investigation - Physical Inspection

- No remains of the pallet of cardboard boxes were found
- Removed by Police/Civil Defence

- “No smoking” signs
- Hundreds of cigarette ends
- Makeshift ashtrays

- Widespread abuse of “no smoking” policy
- Cigarette ends deposited into makeshift ashtrays and directly onto the floor
- A glowing cigarette end in contact with cardboard can initiate a smouldering fire in the cardboard
- Transition to flaming: tens of minutes - a few hours
- Represents the most probable cause

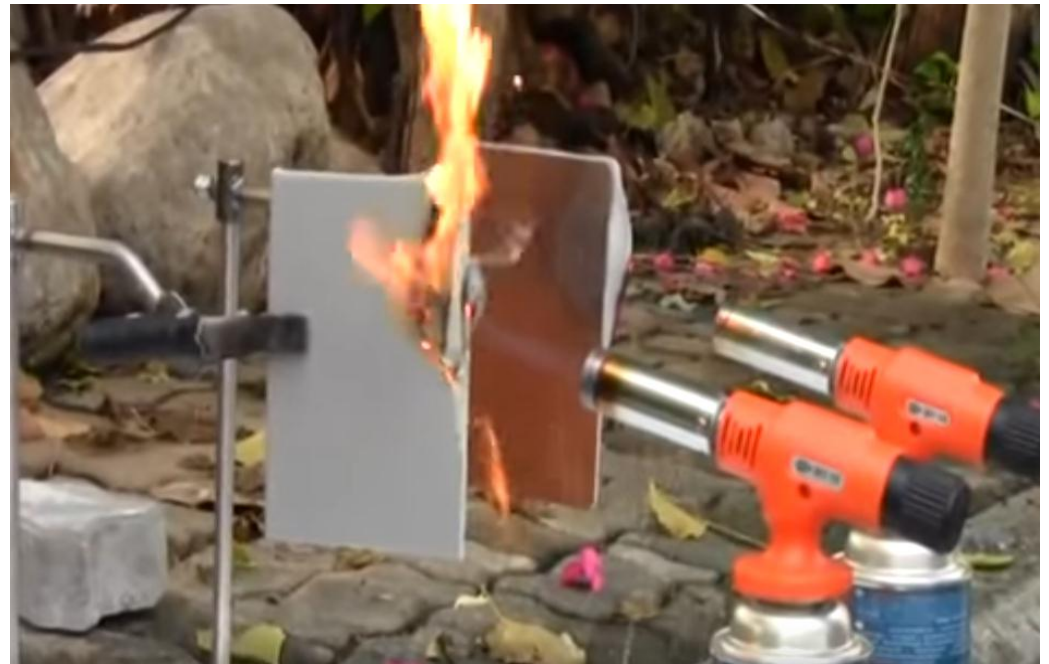
# Investigation - ACP Cladding

- Core was polyethylene plus fire retardants
- Difficult to ignite but nonetheless combustible if exposed to high enough thermal load
- Confirmation by *ad hoc* testing

- Flaming fire developed and spread to ACP
- Combustible nature of ACP → rapid vertical fire spread
- Development of internal fires on multiple storeys
- Sprinkler system was quickly overcome
